REPORT 109444 - 2A - V1.0

PREPARED FOR HUMPTY'S FALL BREAKER LTD

ROOF SAFETY MESH TESTING

15. Supplementary Notes This report summarises the findings of testing completed on the performance of Humpty's Fall Breaker membrane safety mesh. The material was supplied and subjected to dynamic loadings in accordance with AS/NZS 4389:1996. The specimens were deemed to meet the requirements of AS/NZS 4389:1996, and additional testing as requested by the client.

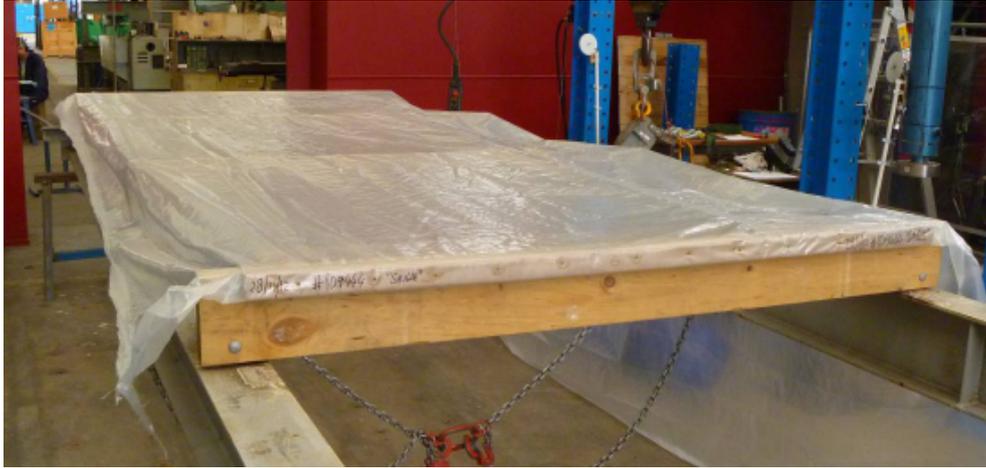
Figure 1 –Installation detail as per AS/NZS 4389:1996

Testing was in accordance with AS/NZS 4389:1996 Standard. Figure 1 shows a typical installation arrangement. Additional test setup is shown in Figure 2.

As per the AS/NZS 4389:1996, purlins were placed at 1500mm centres with a span of 2000mm. The purlins were attached to steel plates welded to a 200mm I-beam section. The safety mesh was placed over the purlins and attached at either end only.

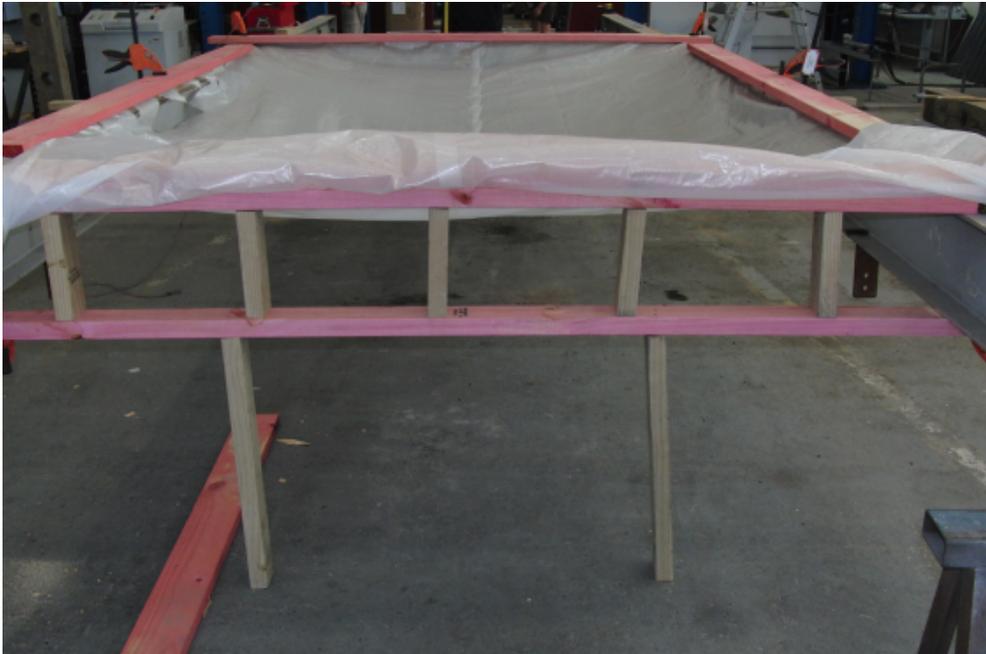
Figure 2 – Additional test setup as per client instructions

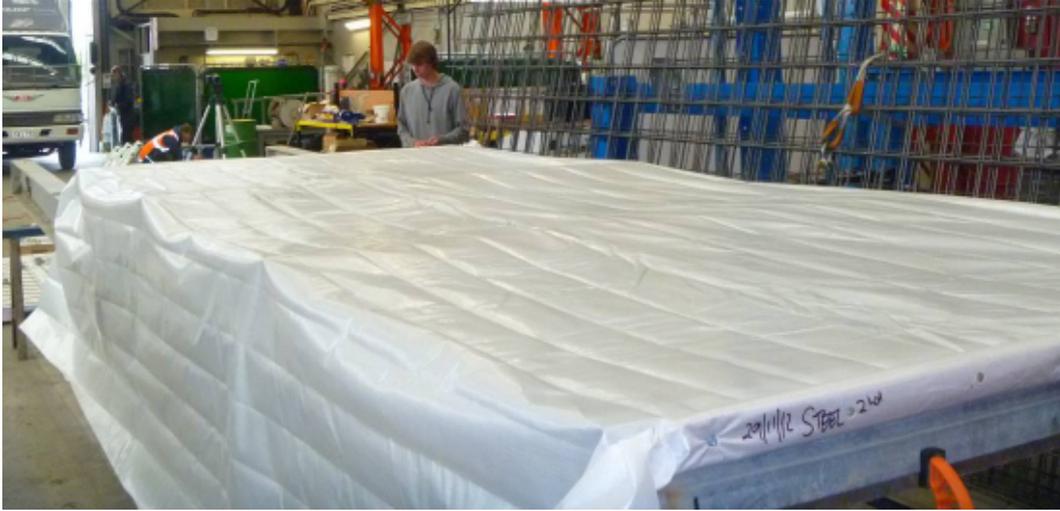
The specimen supplied consisted of 4 test sheets, approximate sizes were 5.0 x 2.5m, the sheets had a welded lap seam that ran perpendicular to the structural support members. Figure 3 shows the sample supplied for testing.

Figure 3 – Typical sample of safety mesh sheeting

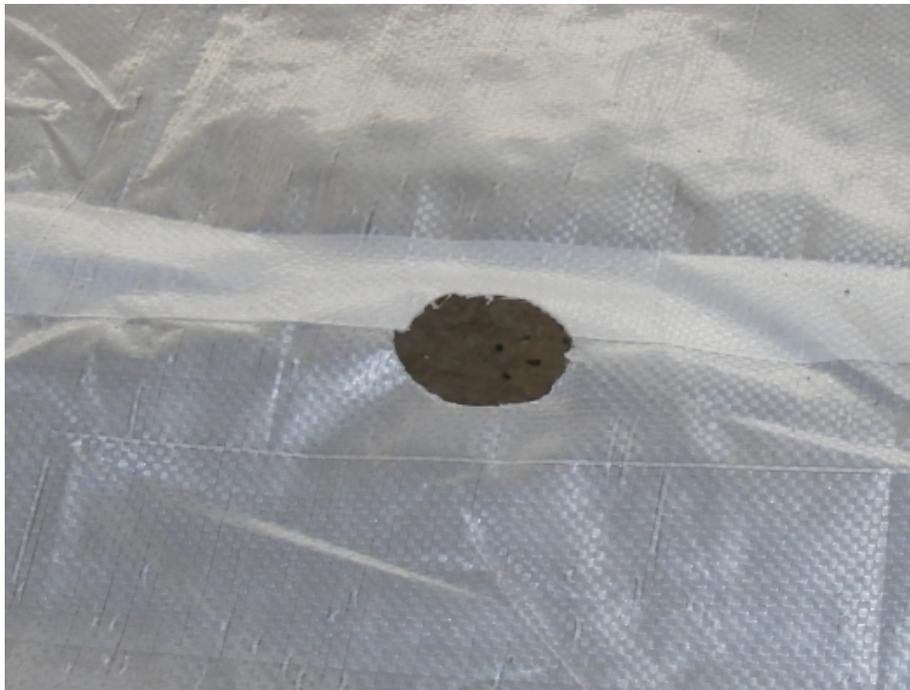
Added to all test sheets was an Ø50mm hole in the centre of the test sheets to act as a drainage hole. Figure 4 shows a typical hole in safety mesh.

Figure 4 – Typical hole in safety mesh sheeting

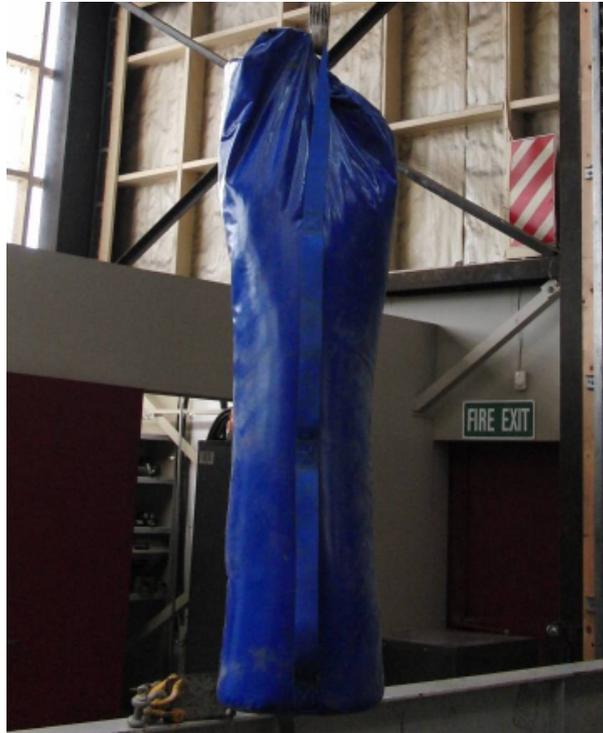
As per the Standard, the test load shall consist of a sand bad approximately 1500mm long by 350mm diameter which weighed 165 kg. Figure 5 shows the test load used for testing.

Testing is completed by dropping the test weight, in a horizontal orientation onto the mid-span of the membrane from a free fall height of 1400 mm.

Figure 5 - Test load for inducing dynamic load

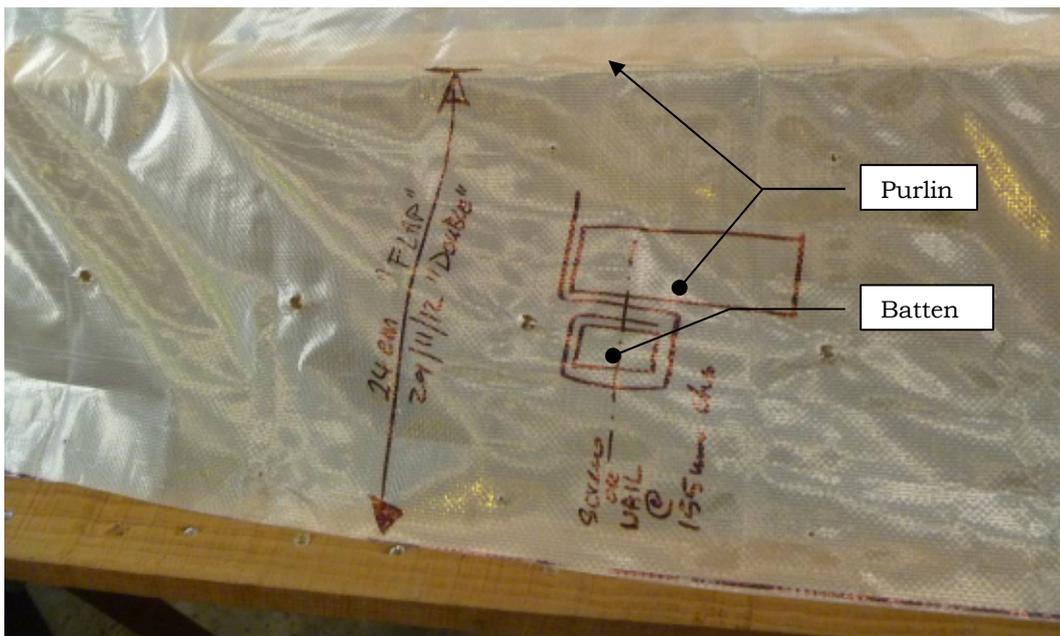
The proposed attachment method was to wrap the over hanging material around a 50x25mm timber batten, the batten was attached to the side of the purling at 200mm centre's with screws when installed on a timber purlin and 200mm centres when installed with a steel purlin. Figure 6 shows detail of the connection end. In accordance with AS/NZS 4389:1996, no side attachment of the membrane was utilised.

Figure 6 – Unwrapped section of safety mesh at connection end

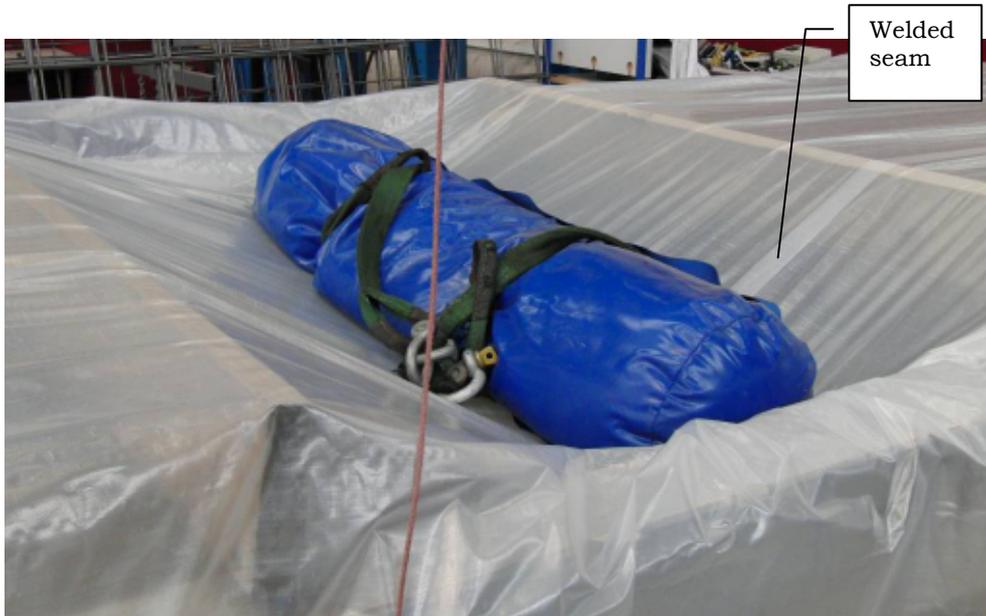
Figure 7 – Timber purlin test 1 results

Purlin construction	Dynamic loading [kJ]	Result
Timber test 1	2.5	Passed
Timber test 2	2.5	Passed
Steel test 1	2.5	Passed
Steel test 2	2.5	Passed

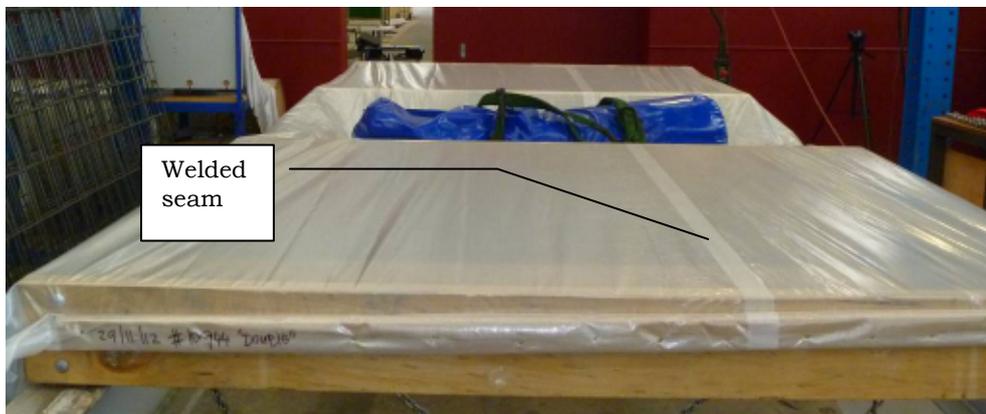
Figure 8 – Timber purlin test 2 results

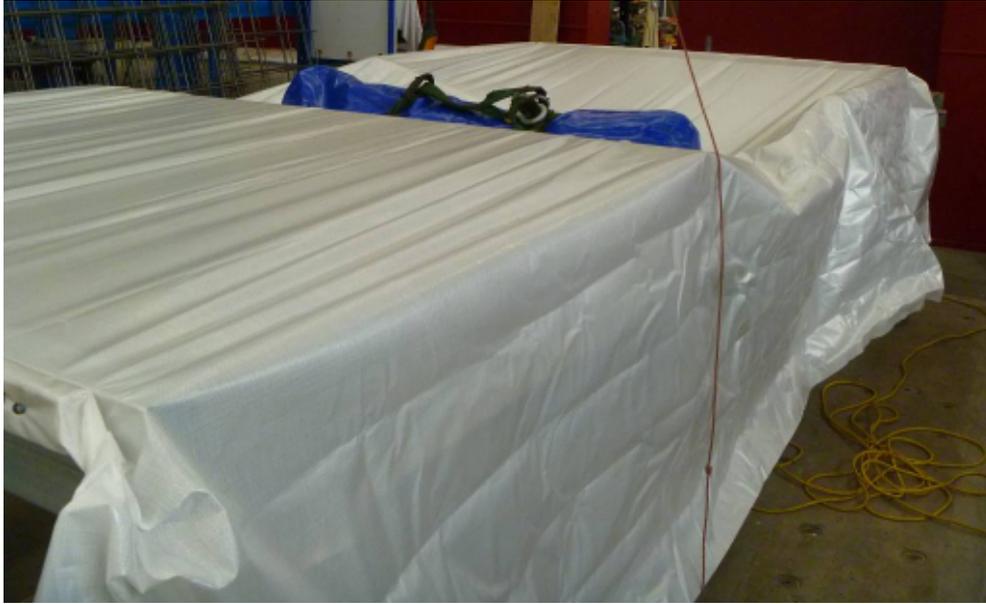
Figure 9 – Steel purlin test 1 results

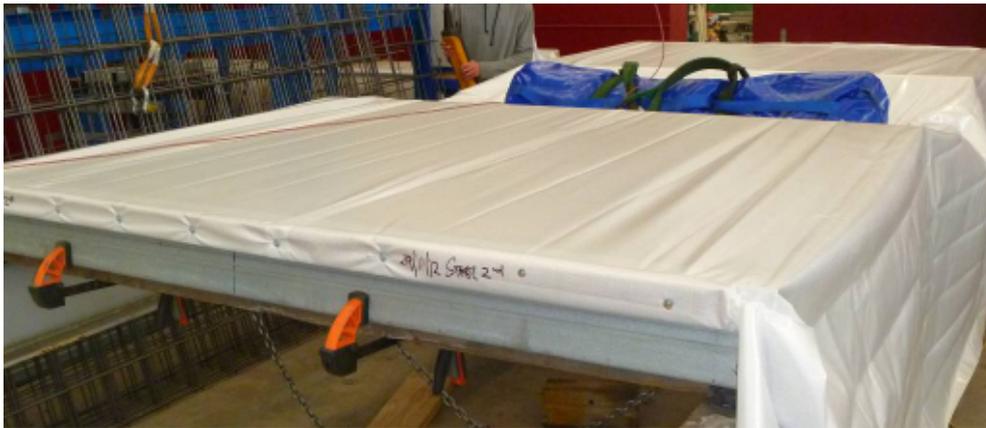
Figure 10 – Steel purlin test 2 results

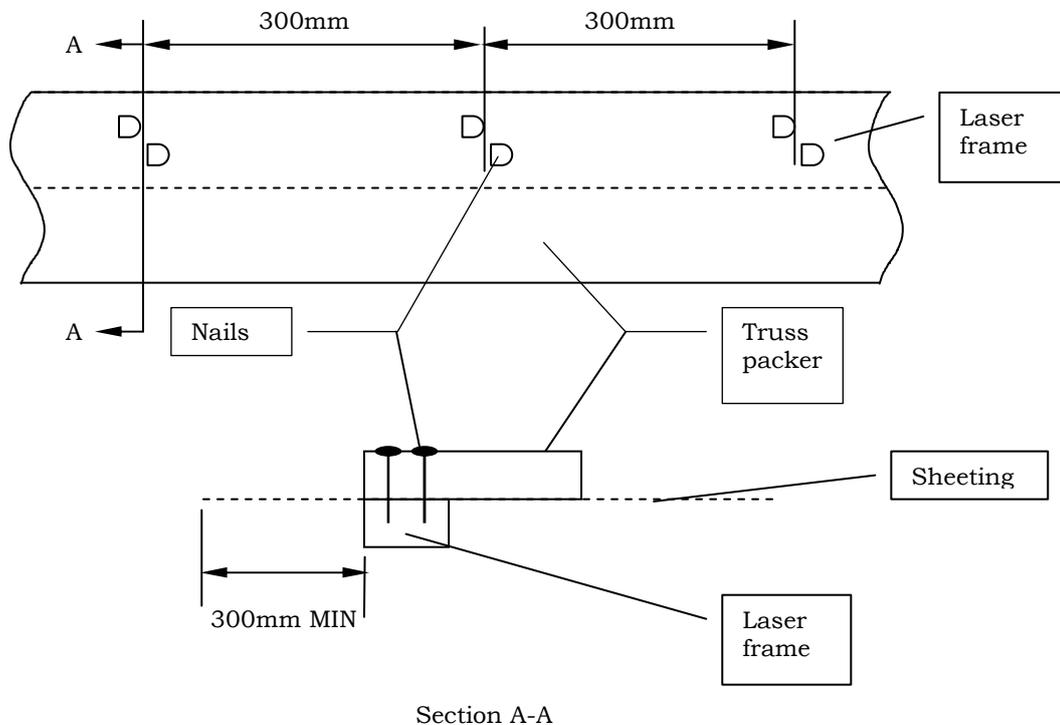
The proposed alternative attachment details are designed around a typical house construction. The support frame consisted of a 90x45mm Laser frame constructed in a 4x3m layout. The safety mesh was draped over the laser frame and restrained via truss packer timber (140x35mm). The safety mesh was installed with a minimum of 300mm overhang on all edges. The truss packer is attached to the laser frame via a nail gun, 2 nails attached at 300mm centre's, the nails are applied in a diagonal pattern, at 45°, see Figure 11.

Figure 11 - Alternative attachment details

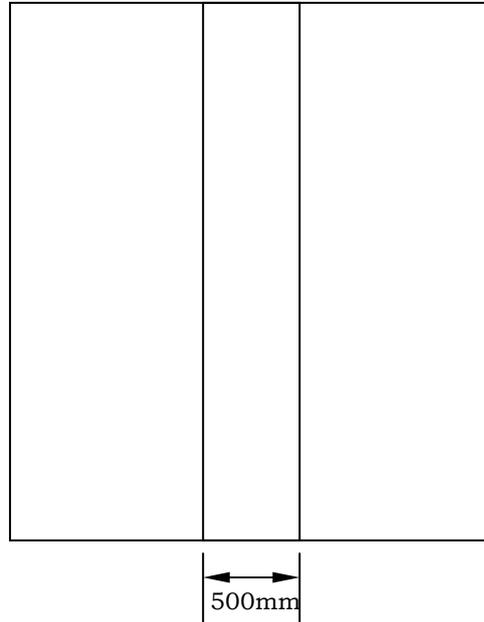
Additional to the drop test, was an overlap test, two separate sheets of safety mesh were overlapped by 500mm, the object of the exercise was to confirm that the test weight

would not penetrate the overlapped mesh sheets. The testing procedure was identical to previous testing. Figure 12 shows the overlap test setup.

Figure 12 - Overlap test setup

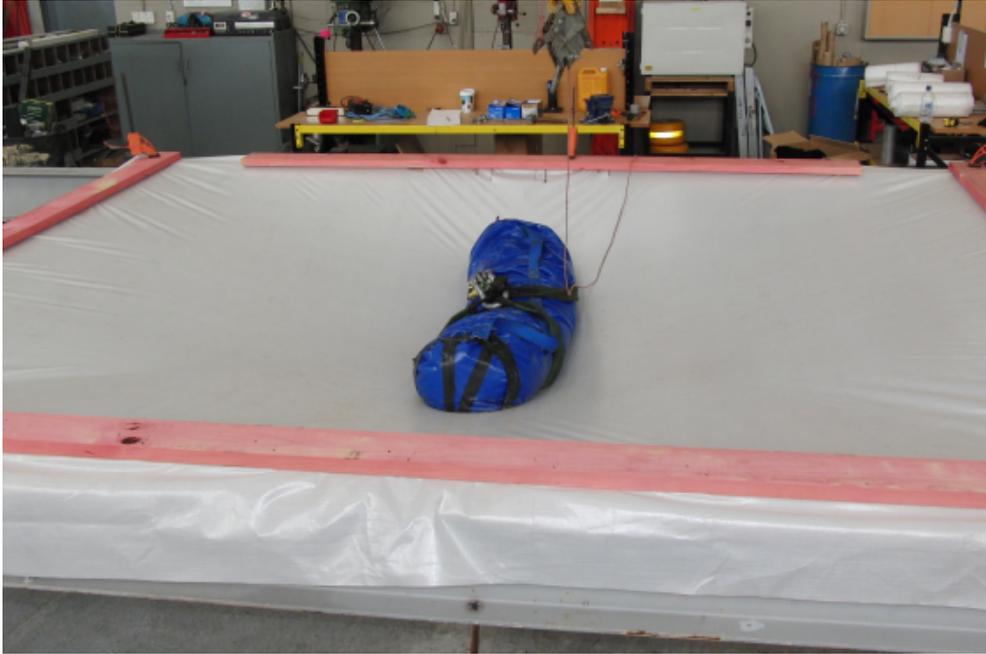
The test results based on this testing showed that the alternative attachment methods withstood the drop test. Figure 13 shows the alternative attachment method after the initial drop test. The overlap test results showed that a 500mm overlap supported the test load without the test weight penetrating the test sheets.

Figure 13 – Drop test result with alternative attachment method
